Tiago Miguel Nico Pereira

Experimental Campaign Addressing Lap-Splices under Cyclic Loading

Dissertação para obtenção do Grau de Mestre em
Engenharia Civil

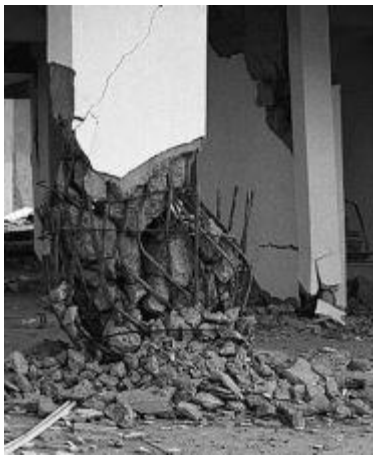
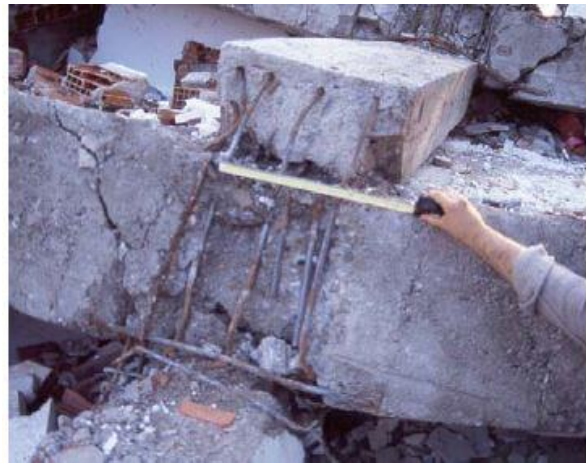
Post-field observations shown that the behavior of splices may have played a role on the collapse of buildings in 1999, Turkey. Figure 2.5 (b) shows a typical beam-column connection for a six-floor building and the failure surface indicates that longitudinal bars of the column were inadequately anchored and probably they were pulled out at relative low load levels. (Melek, et al., 2003)

The reports made after the fields observation show that the Turkish earthquake code provisions were not followed in detailing reinforced concrete columns, especially in potential plastic hinge zones at the end of the columns. As shown by figure 2.5 (a) lap splices were typically made at the column bottom (floor or foundation interface) without the needed confinement to perform in a ductile way. The reports have also showed that the buildings that featured shear walls as structural elements generally didn't manifest much damage under the seismic event. (Sezen, et al., 2002)

Figure 2.5: Field Observations after Turkey Earthquake in 1999 (Melek, et al., 2003; Sezen, et al., 2002)

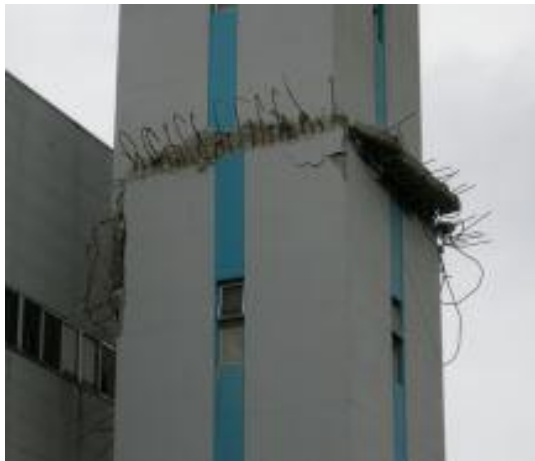
Lap splices also contributed to the failure of a chimney. During the Niigata-ken Chuetsu-Oki earthquake in Japan a chimney with 58 m height failed. Figure 2.7 shows the damage on the chimney at the lap splice zone at approximately 17.5 m from the ground level.

Figure 2.7: Lap splice damage on a chimney during Niigata-ken Chuetsu-Oki earthquake (Kim, et al., 2012)
